# Shaped by geography: appropriate construction materials for safer schools in Nepal

## Overview

**Summary:** Nepal is severely exposed to a variety of natural hazards. After the 2015 Gorkha earthquake, the World Bank carried out an extensive survey programme of 21,000 public school buildings in the 14 most affected districts to inform a safe schools investment programme. In developing the survey methodology and by analysing survey data, valuable information was gathered about local materials, school construction typologies and performance of existing schools. The challenge that remains to be addressed in Nepal is to identify locally appropriate materials and construction types for schools for a diverse range of geographical contexts as well as a range of local capacity and capability in construction techniques.

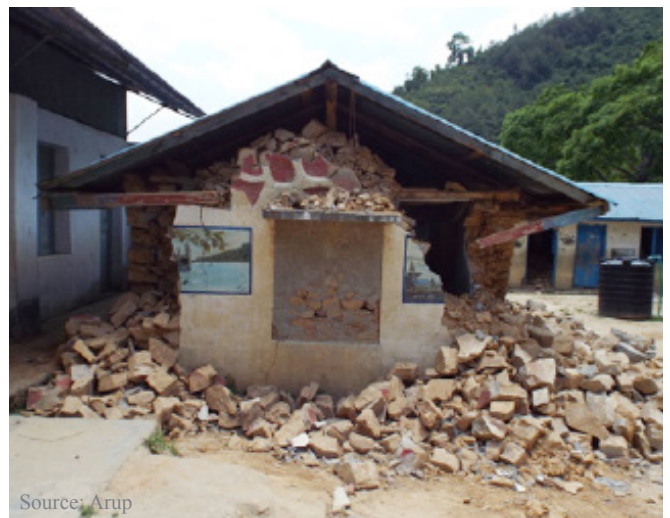
Damaged stone masonry school in Lalitpur, Nepal

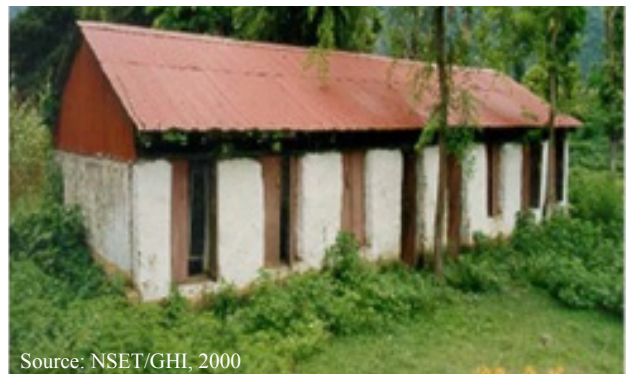
Source: NSET/GHI, 2000  
Steel frame school design with stone infill walls using mud mortar

transport in and local materials are often limited to rubble stone and mud mortar, which, if used for construction, perform very poorly in earthquakes. This was demonstrated in the performance of a model school typology with a lightweight steel frame and community built infill walls. Where the walls were built using rubble stone or brick with mud mortar, they often suffered serious damage or collapse in the earthquake.

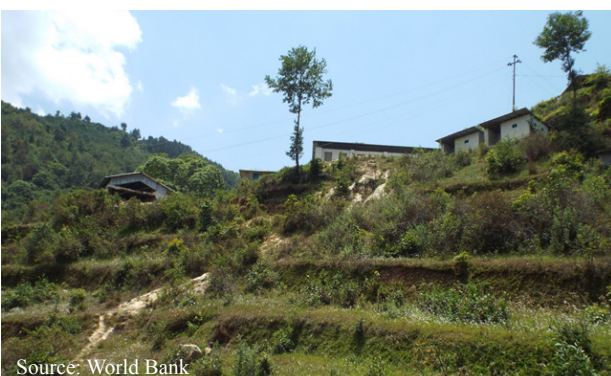
Many schools sites are located on steep slopes

More than three-quarters of schools are sited on foothills or mountainous terrain outside of Kathmandu Valley and many schools are on vulnerable sites and exposed to landslides and other foundation failure.
